**Private Public  
Partnership Energy  
Efficiency Assessment  
Program at HAECO  
Xiamen Facility, China**

Tsinghua University was invited to carry out energy audit and give recommendation on HAECO Xiamen energy performance and reduction measures. There are 6 hangars in HAECO Xiamen

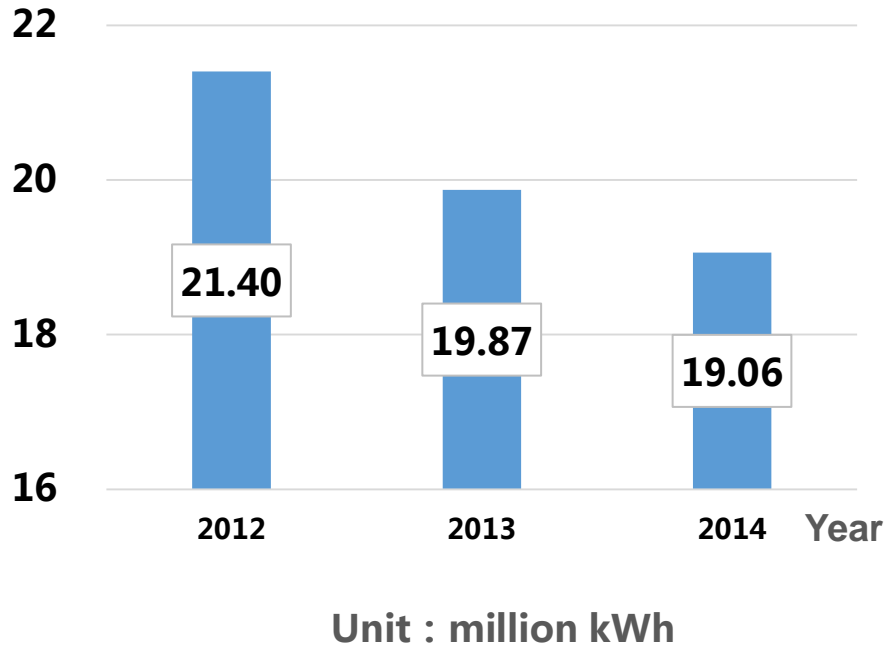
### Total Electricity Consumption

Total Energy Review : 3 types of energy :  
Lighting, Power and A/C units

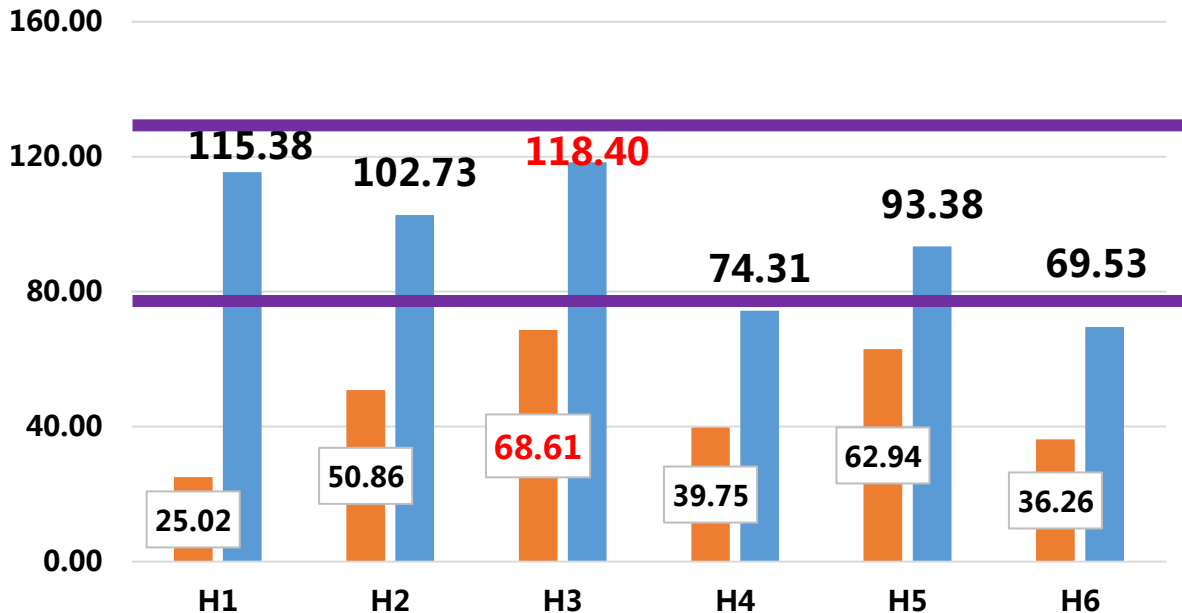
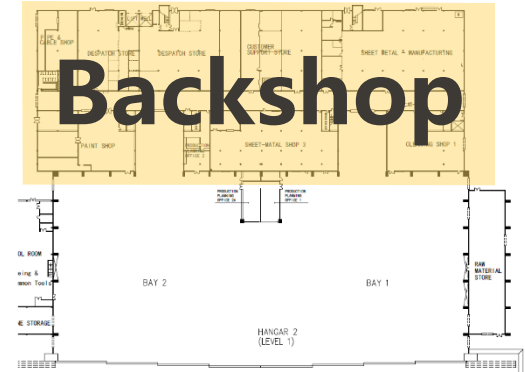
# 2014 Energy Consumption

Unit: kWh/m<sup>2</sup>-year

- H3 Bay has consumed **highest** energy.
- **Large potential** in AC.

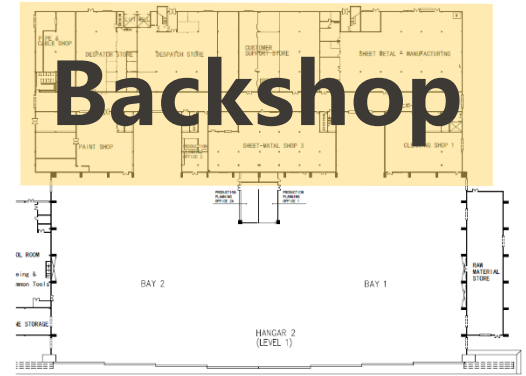
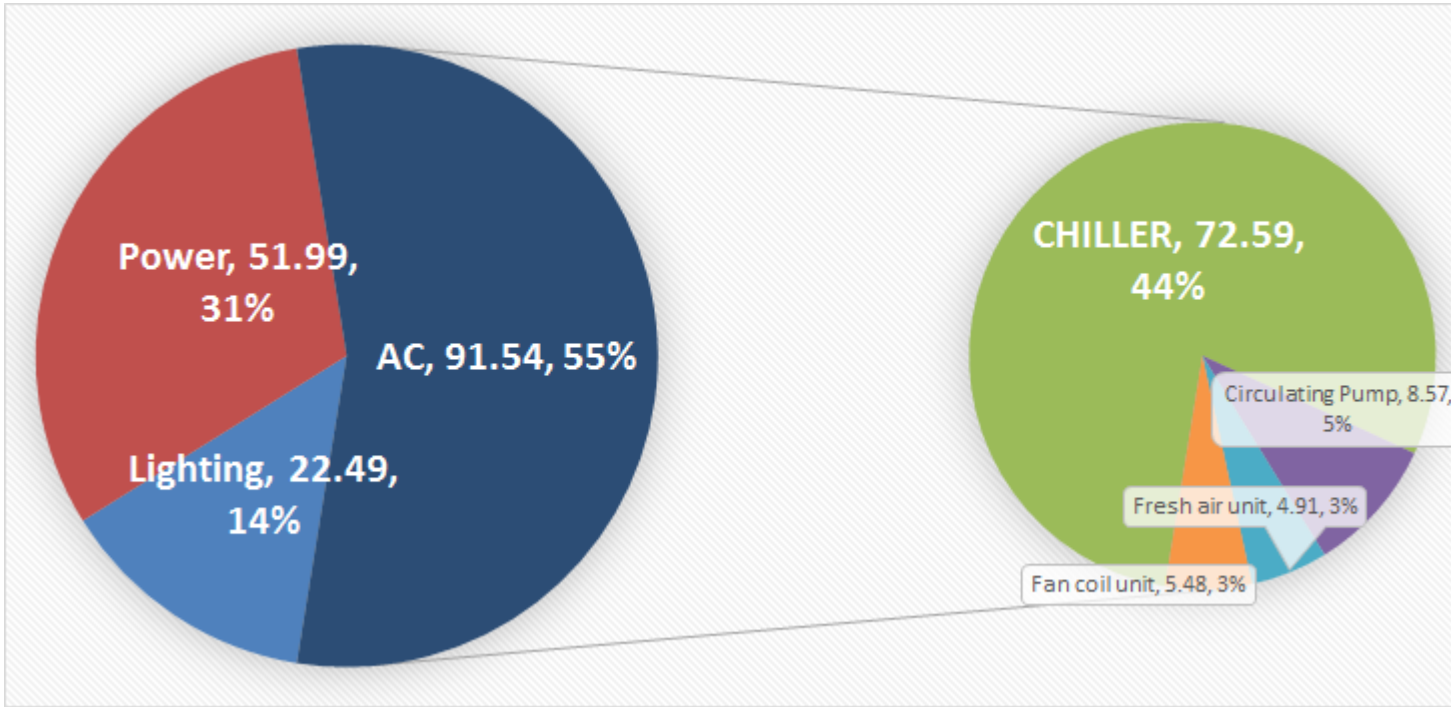
# Detailed Energy Analysis of H3

Unit: 10,000 kWh

- H3 AC(Backshop) has consumed **55% of total energy.**
- **Large potential** in H3 AC.

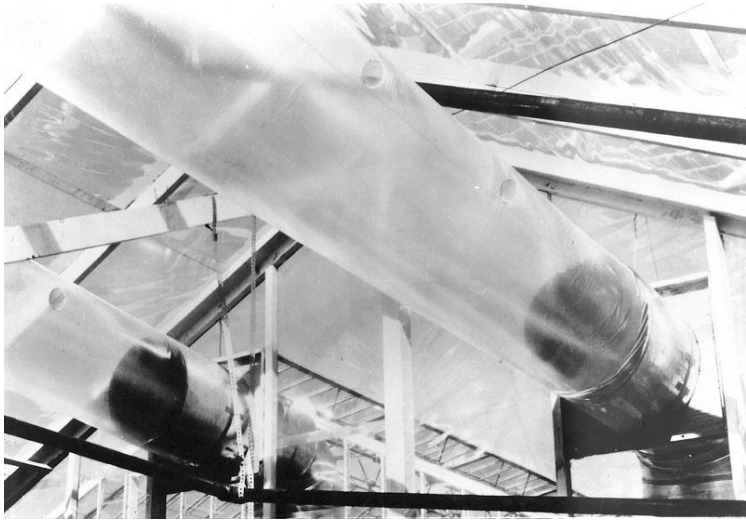
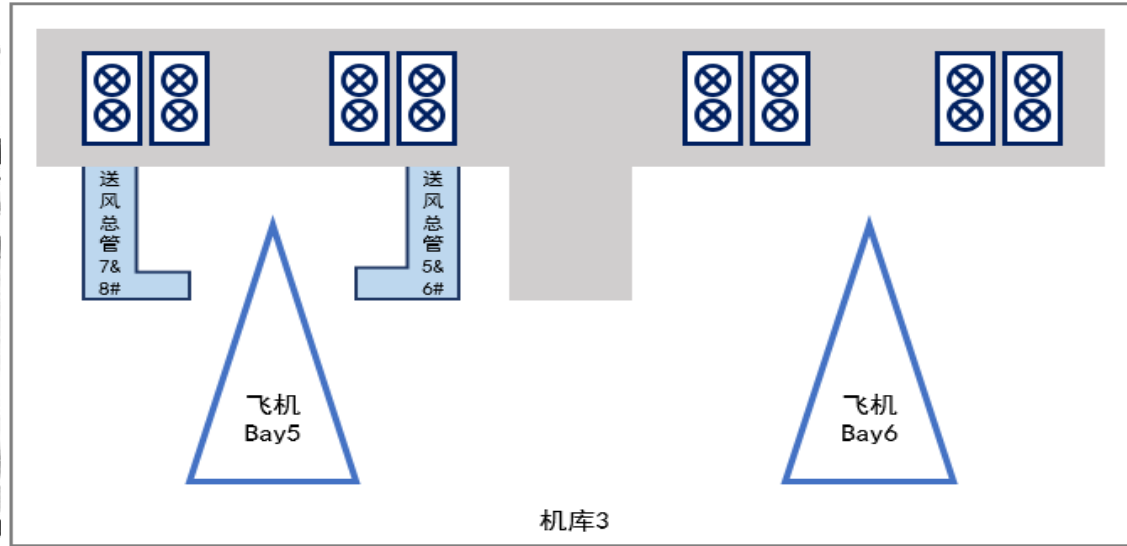
## Cabin chilled air units

Chiller number	Measured COP*
5	3.2
6	2.9

- Low chiller efficiency
- Some fans are not working
- Fans are switched without considering the need, causing unnecessary waste

- Low chiller efficient and usage
  - ✓ Chiller and wind pipe controlling
- Large fan energy consumption
  - ✓ Using frequency inverting fan or more small fans
- The waste of cold wind
  - ✓ Increasing proportion of mobile air-conditioning unit
  - ✓ Strengthen management of the valves
- Total energy saved : **1.08 million kWh per year** accounted for **75%**

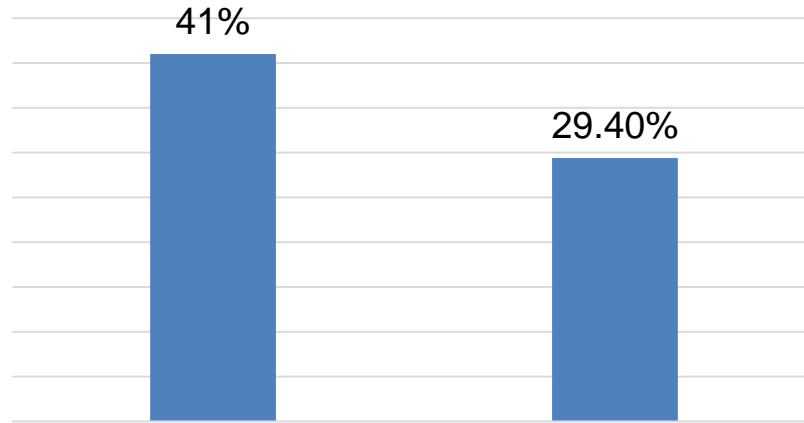
AC usage ratio

- Supply exceeding demand

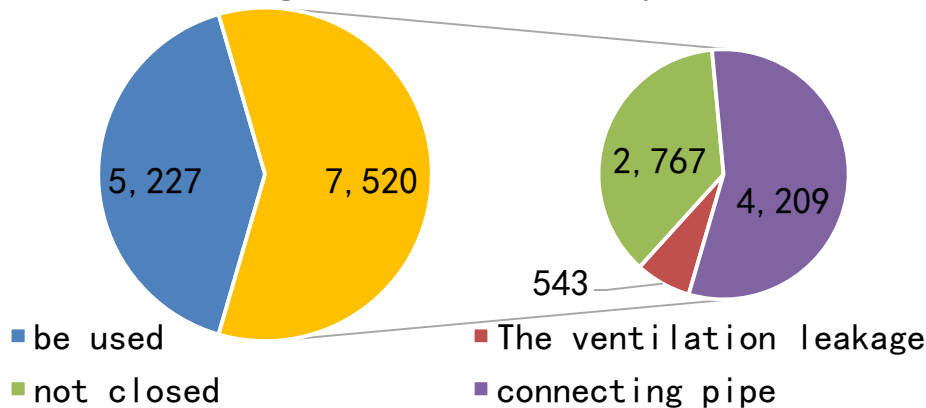
The usage of cold capacity(m<sup>3</sup>/h)

- Wastage on;
- Ventilation system leakage
  - Aircraft doors are not closed
  - Connecting pipe leak

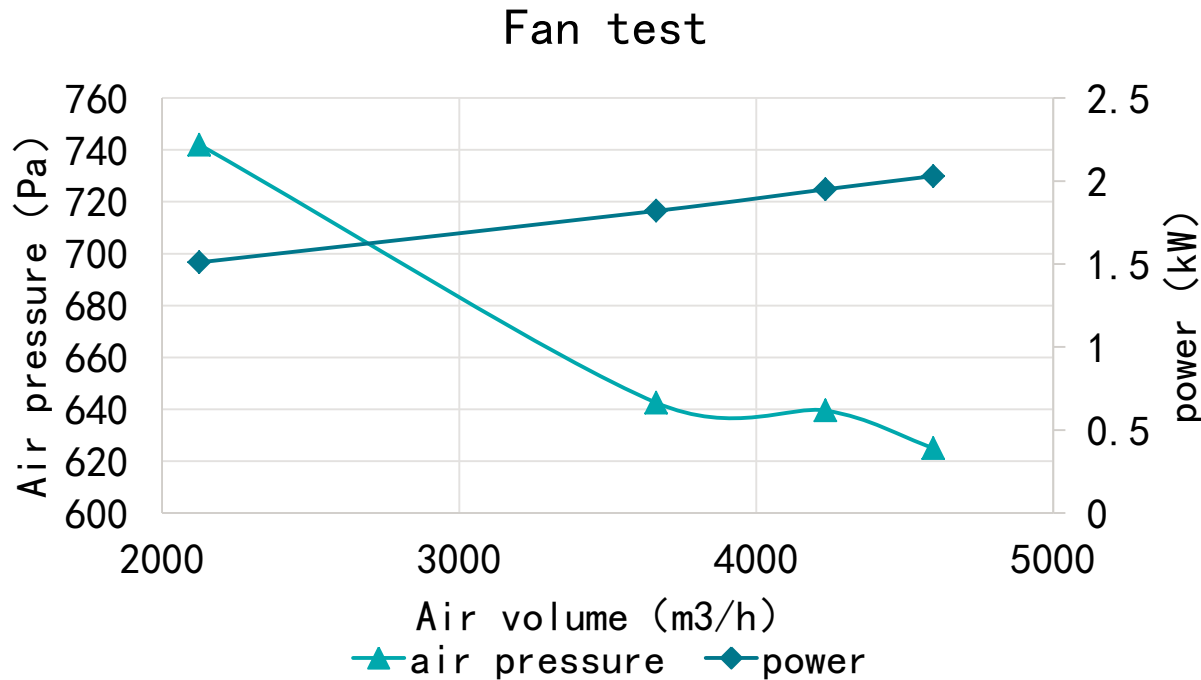
## Fan test

1. Closed all valves, large amount of air is leaked.
2. Fan power is too large

1. Use frequency inverting fan
2. Use more small fan instead of large fan

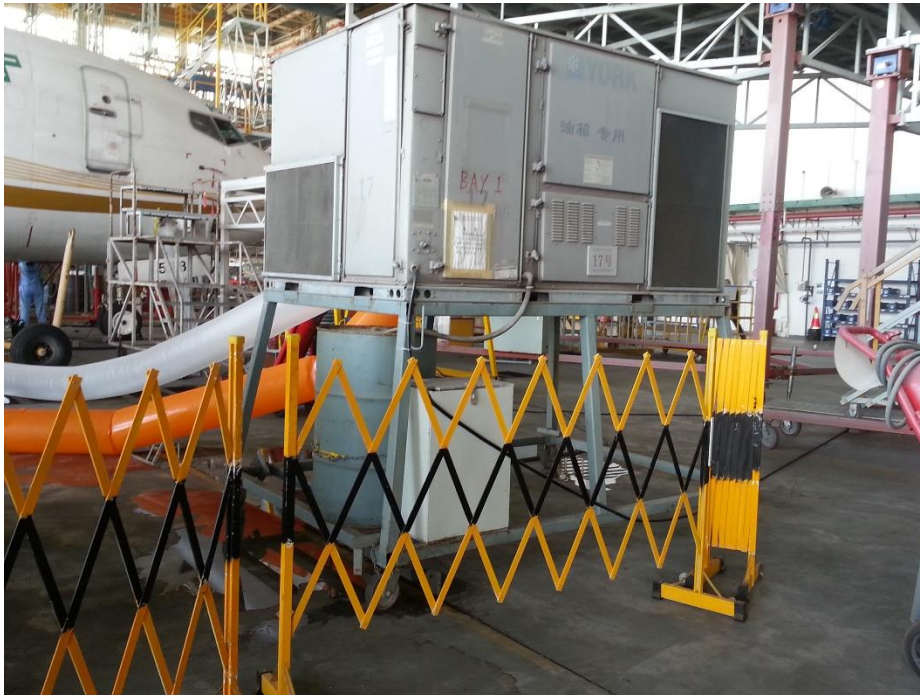
### Air-conditioning vehicle test

- high chiller efficiency ---- 5.3
- Too cold, discomfort feeling

- Mobile air-conditioning unit has high cooling capacity
- Proposal: Increasing proportion of mobile air-conditioning unit

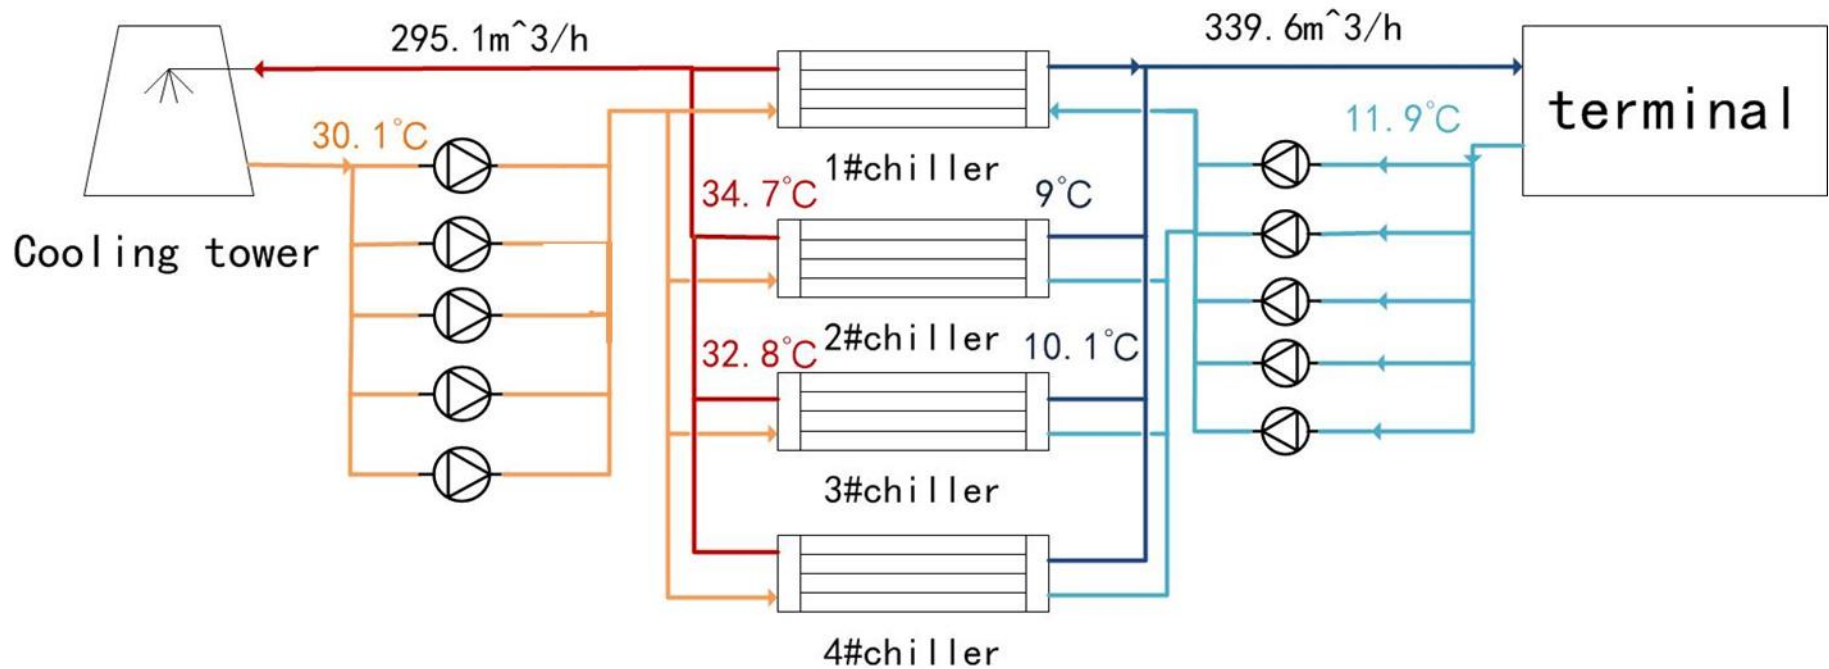
## Operating strategy

- No. 2 & 3 chiller run at 40% cooling capacity
- 2 cooling water pumps and 2 chiller water pumps run at low load
- Low  $\Delta T$  of chilled water system ( $2.9^{\circ}\text{C}$ ), causing large flow and energy consumption

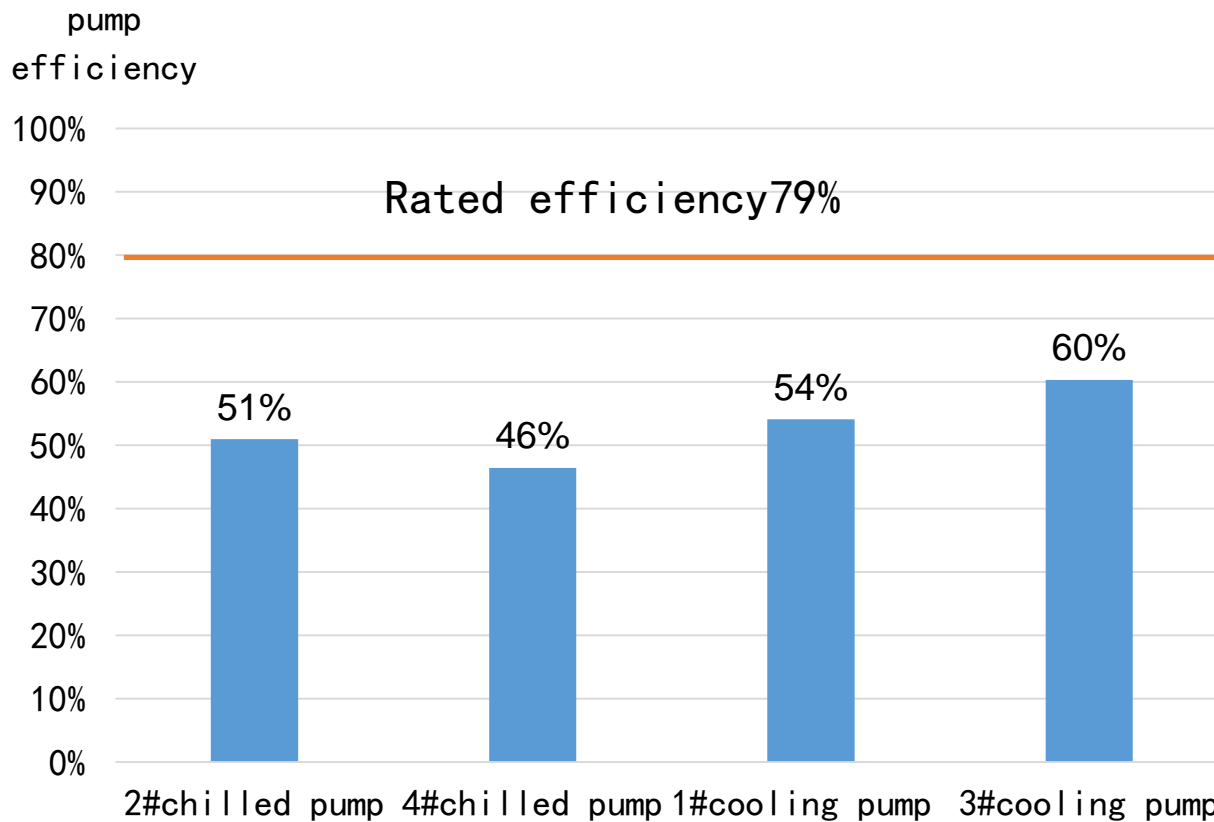
## Operating strategy

- Oversizing design and improper operating strategy of pumps
- System runs at a low efficiency state

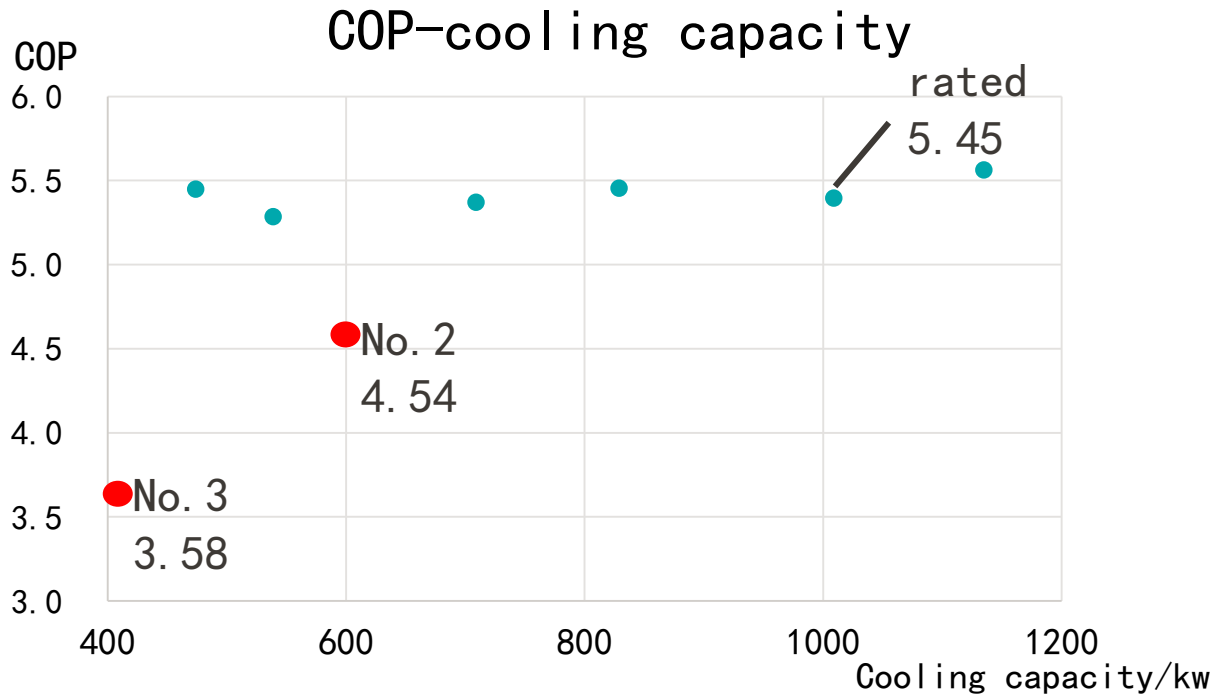
Chiller's coefficient of performance (COP)

No. 2 & 3 chiller runs at 40% cooling capacity

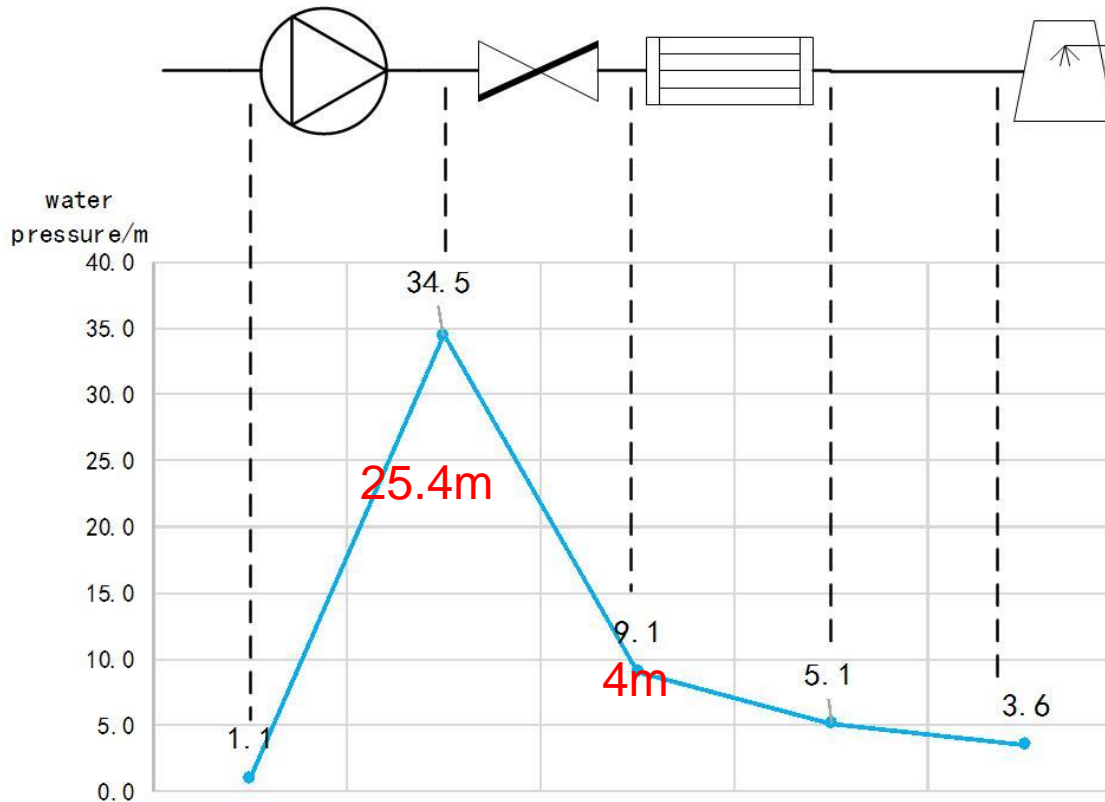
## Cooling water system

Too much water pressure drop!

Cause:  
High energy consumption  
Low efficiency

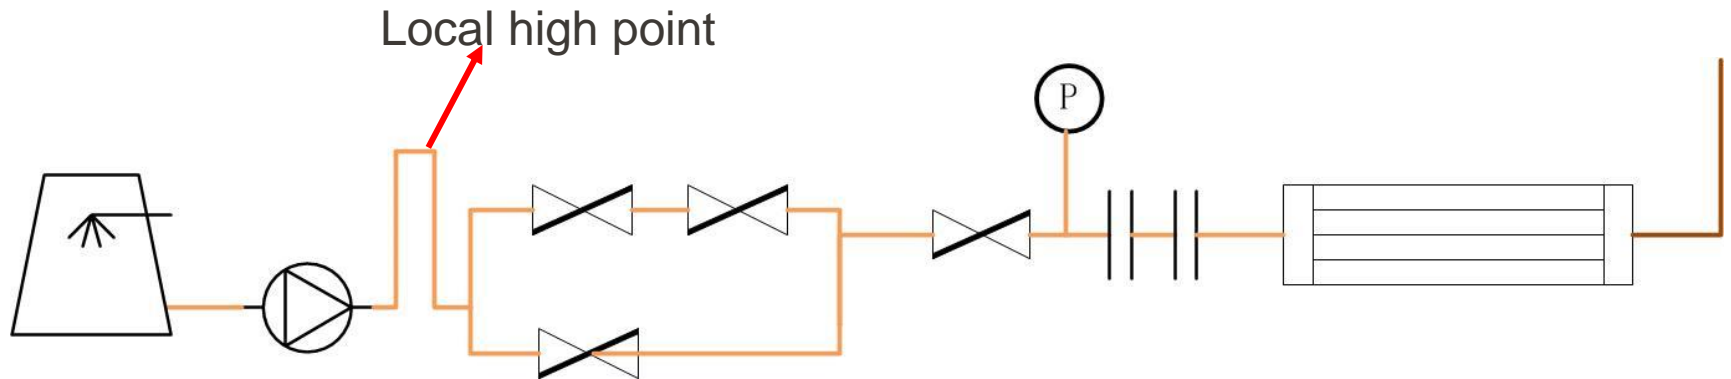
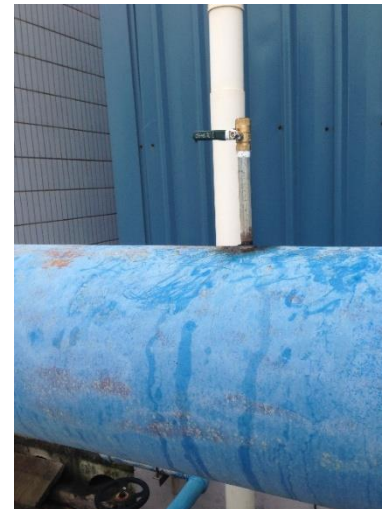
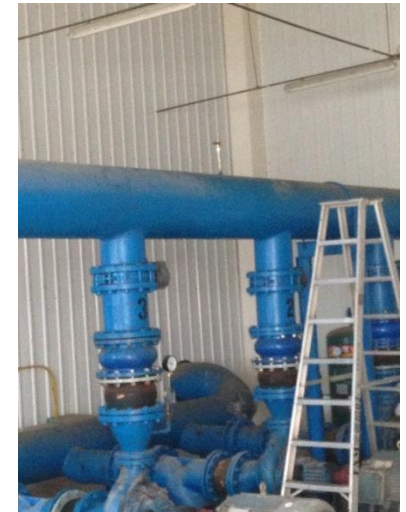
Analysis of causes:

Air stuck in local high point and Condenser. Affecting heat transfer

Solutions:  
Install vent valve

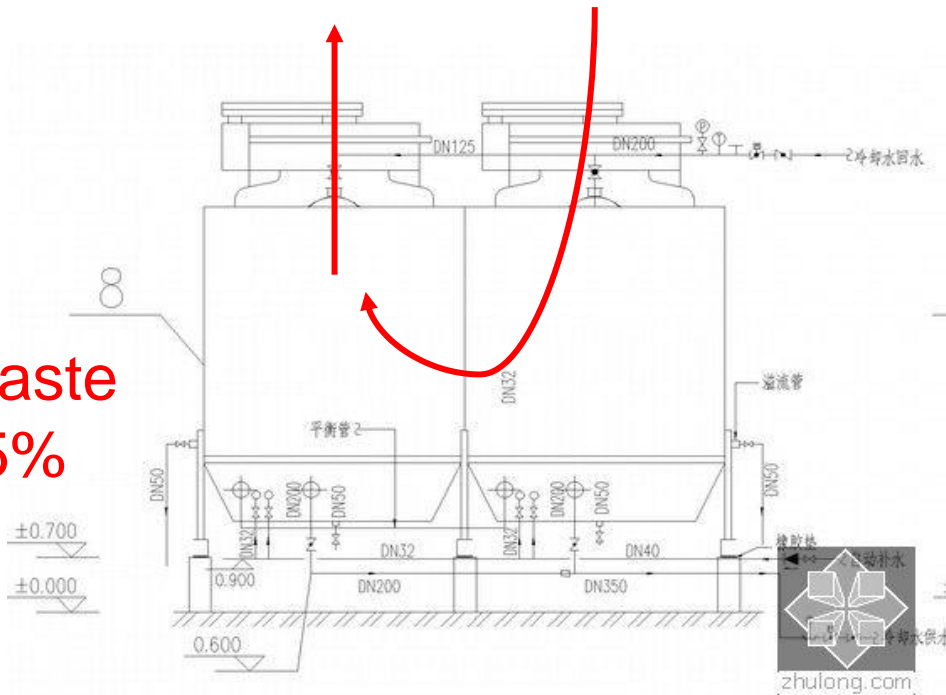
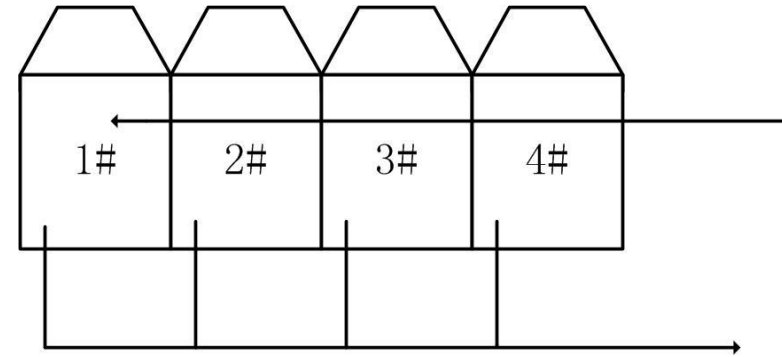
Cooling tower

Operate 3 cooling towers

**Waste  
25%**

efficiency	<b>74%</b>
------------	------------

Suggestion:  
Run 4 cooling towers with frequency inverter

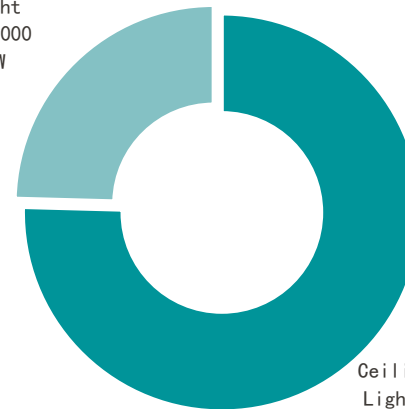
- **Lighting of Bay**
- Test: Ceiling Lamp & Natural Lighting
- Conclusion:
  - Ceiling Lamp **wouldn't improve** the adverse lighting area
  - Natural Lighting **have significant impact** on the total light environment

Other Light  
440,000  
kW

Ceiling Light,  
1,360,000  
kW

If use natural lighting from 1000-1500 hr can save
